AFFDL-TR-71-126

ADVANCED COMPOSITE JOINTS; DESIGN AND ACOUSTIC FATIGUE CHARACTERISTICS

Northrop Corporation

TECHNICAL REPORT AFFDL-TR-71-126

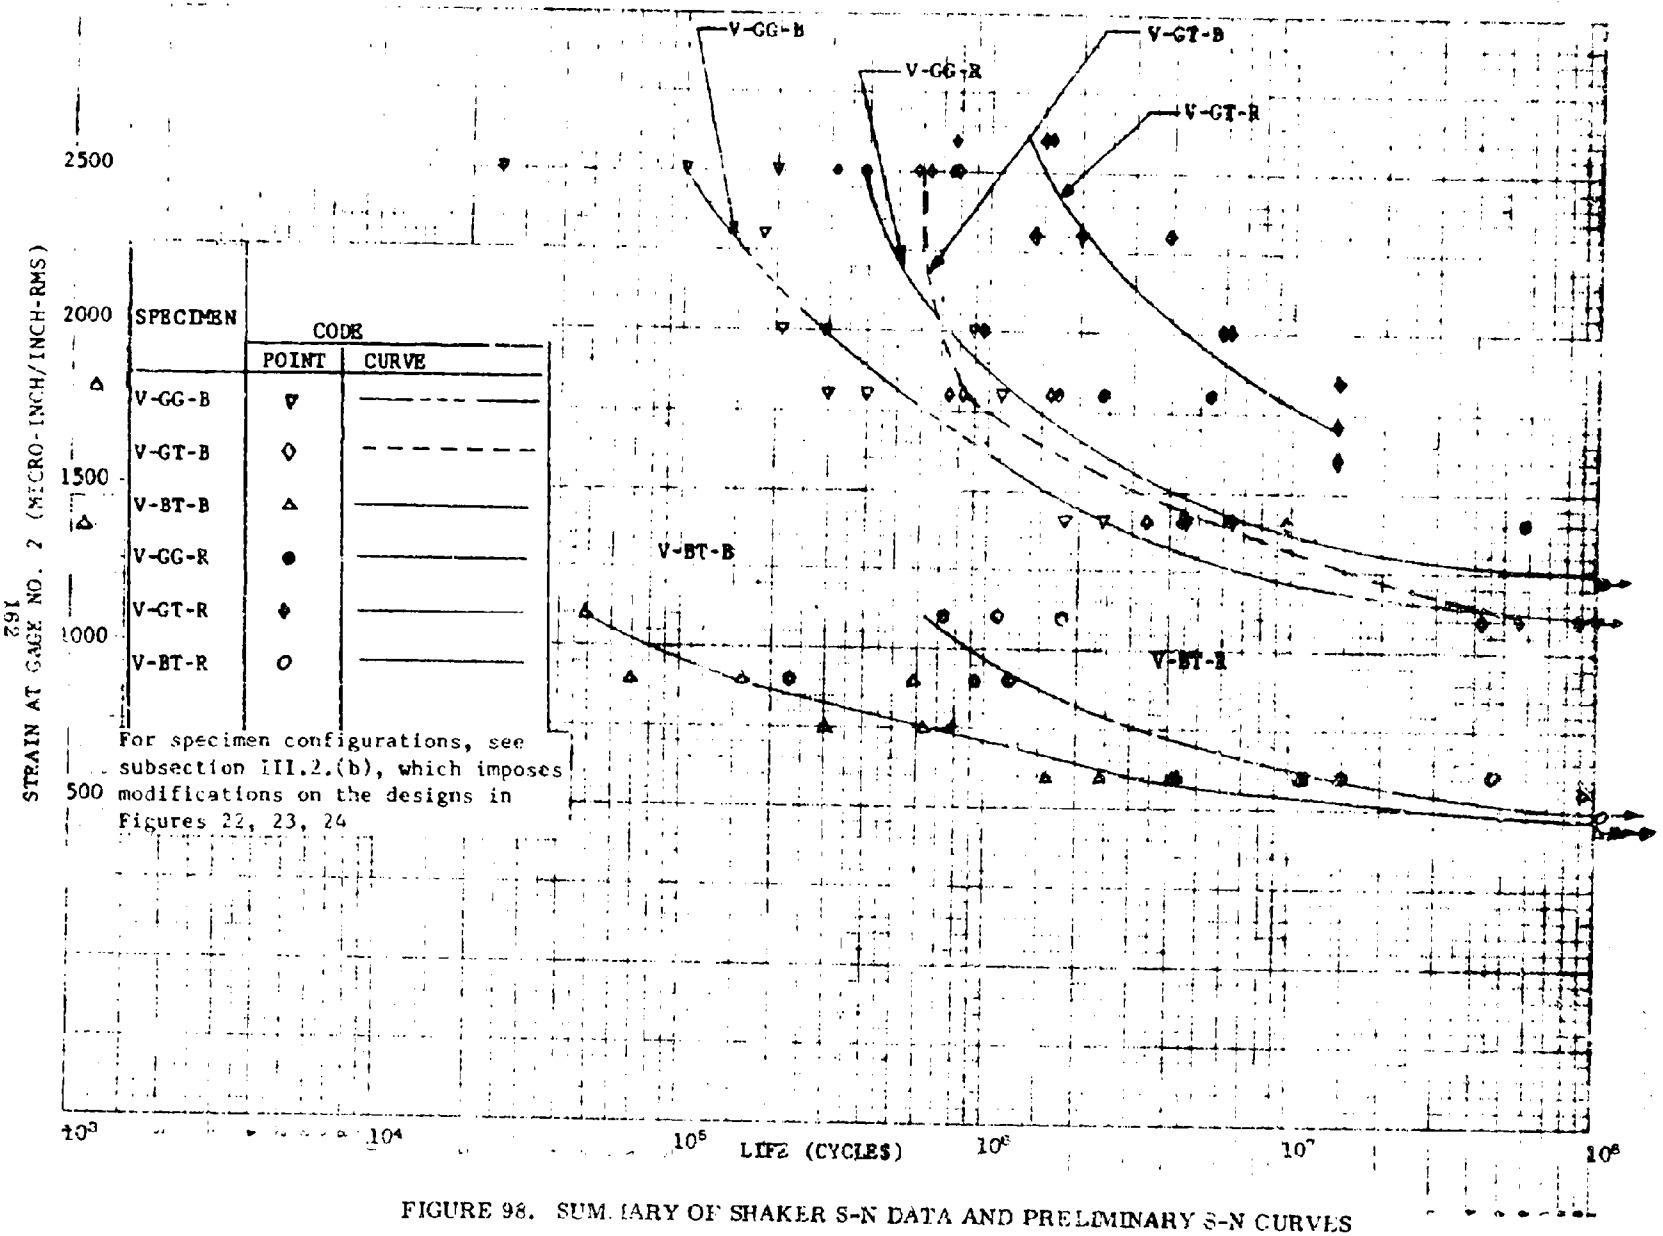
FIGURE 98. SUMMARY OF SHAKER S-N DATA AND PRELIMINARY S-N CURVES

One objective of the shaker test program was to obtain S-N curves with sets of six-ply specimens (one of the sets simulates a portion of the bonded joints of the acoustic test program). The S-N curves of Figure 98 are useful because they indicate life that can be expected from a larger population of different types of test specimens. However, because of the few specimens in each set, the confidence levels associated with life predictions based on the S-N shaker specimen test results are significantly lower than the confidence levels associated with material allowables for the design of metallic aircraft structural elements. However, it does appear that the rms fatigue strain at 10^8 cycles under the narrow band random loading of the six-ply $[90, \pm 45]_S$ graphite-epoxy and boron-epoxy laminates is at least ten percent of the static, ultimate tensile strain of the six-ply laminates.

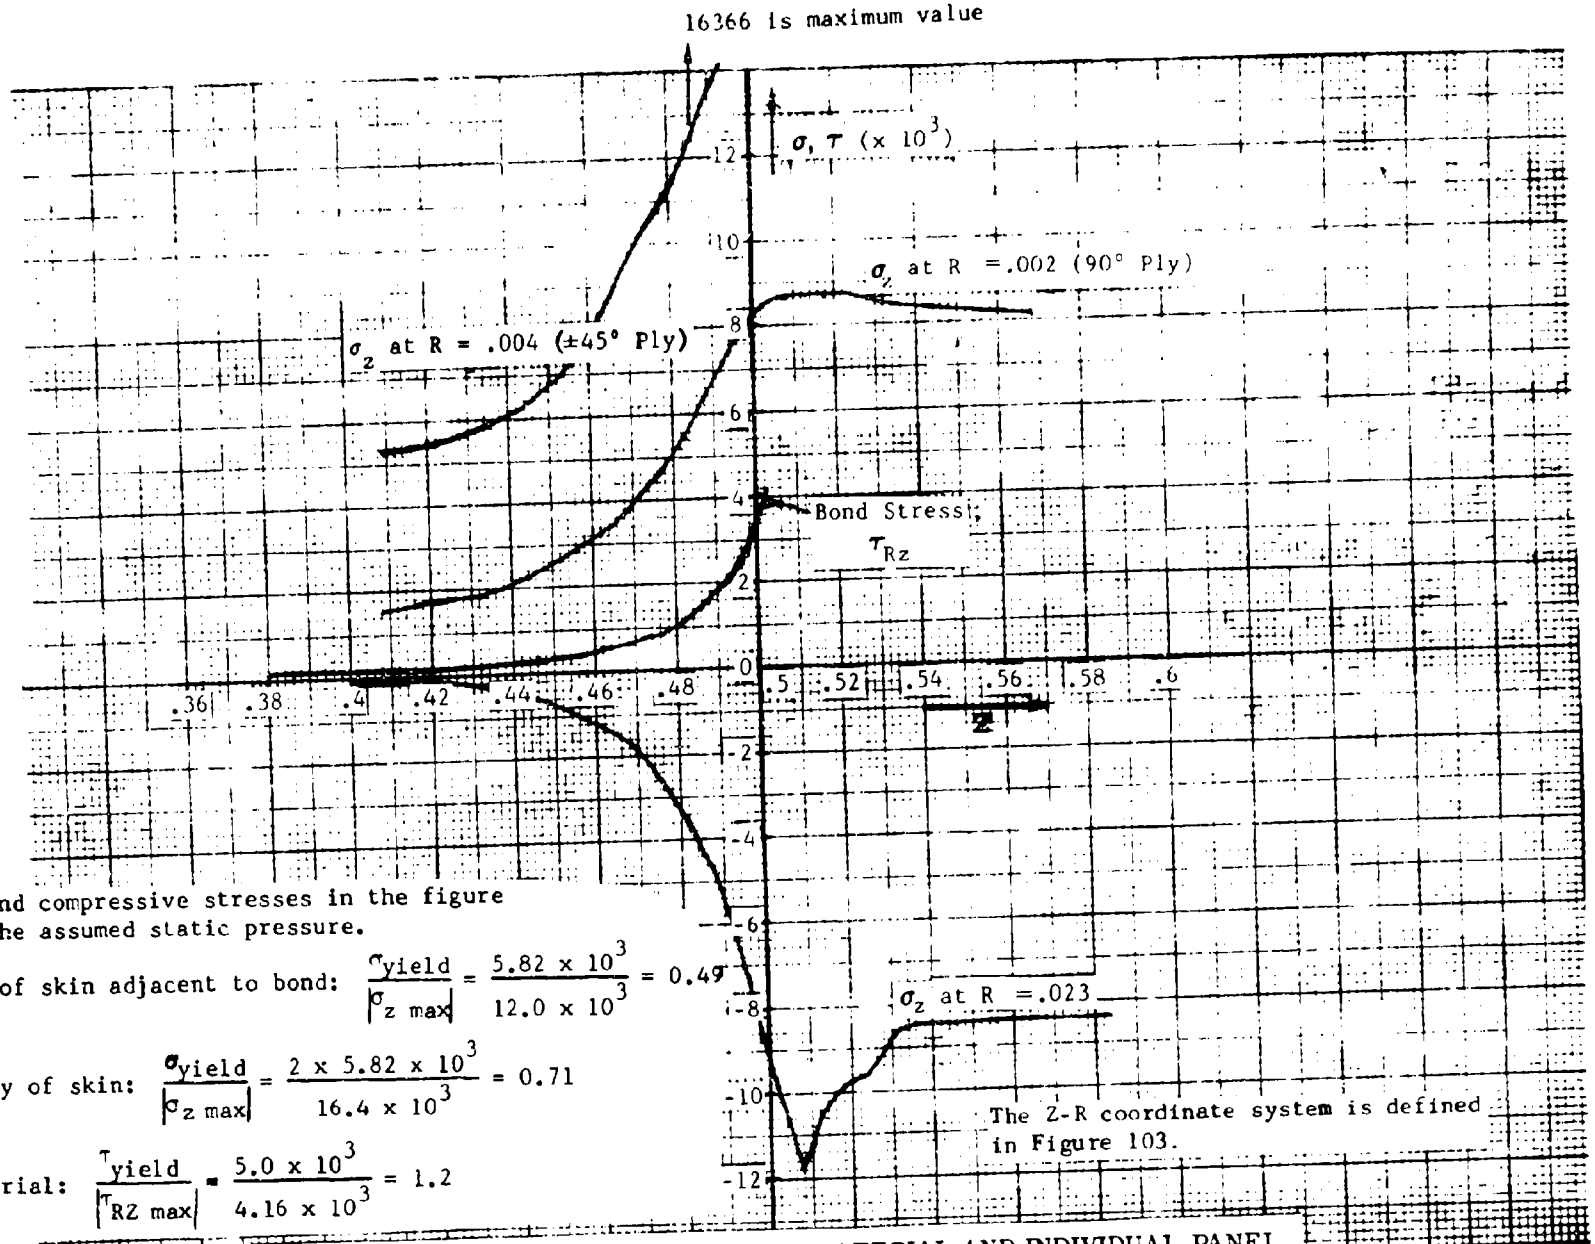
FIGURE 105. STRESSES IN THE BONDING MATERIAL AND INDIVIDUAL PANEL PLIES FOR CASE 1

2. The ratios of yield stresses to developed stresses show that for Case 1 the first fatigue failure is expected to occur in the 90 degree ply of the skin and for Case 2 the first fatigue failure is expected to occur in the bond (see the discussion below).

90° - ply of skin adjacent to bond: $\dfrac{\sigma_{yield}}{|\sigma_{z\ max}|} = \dfrac{5.82 \times 10^3}{12.0 \times 10^3} = 0.49$

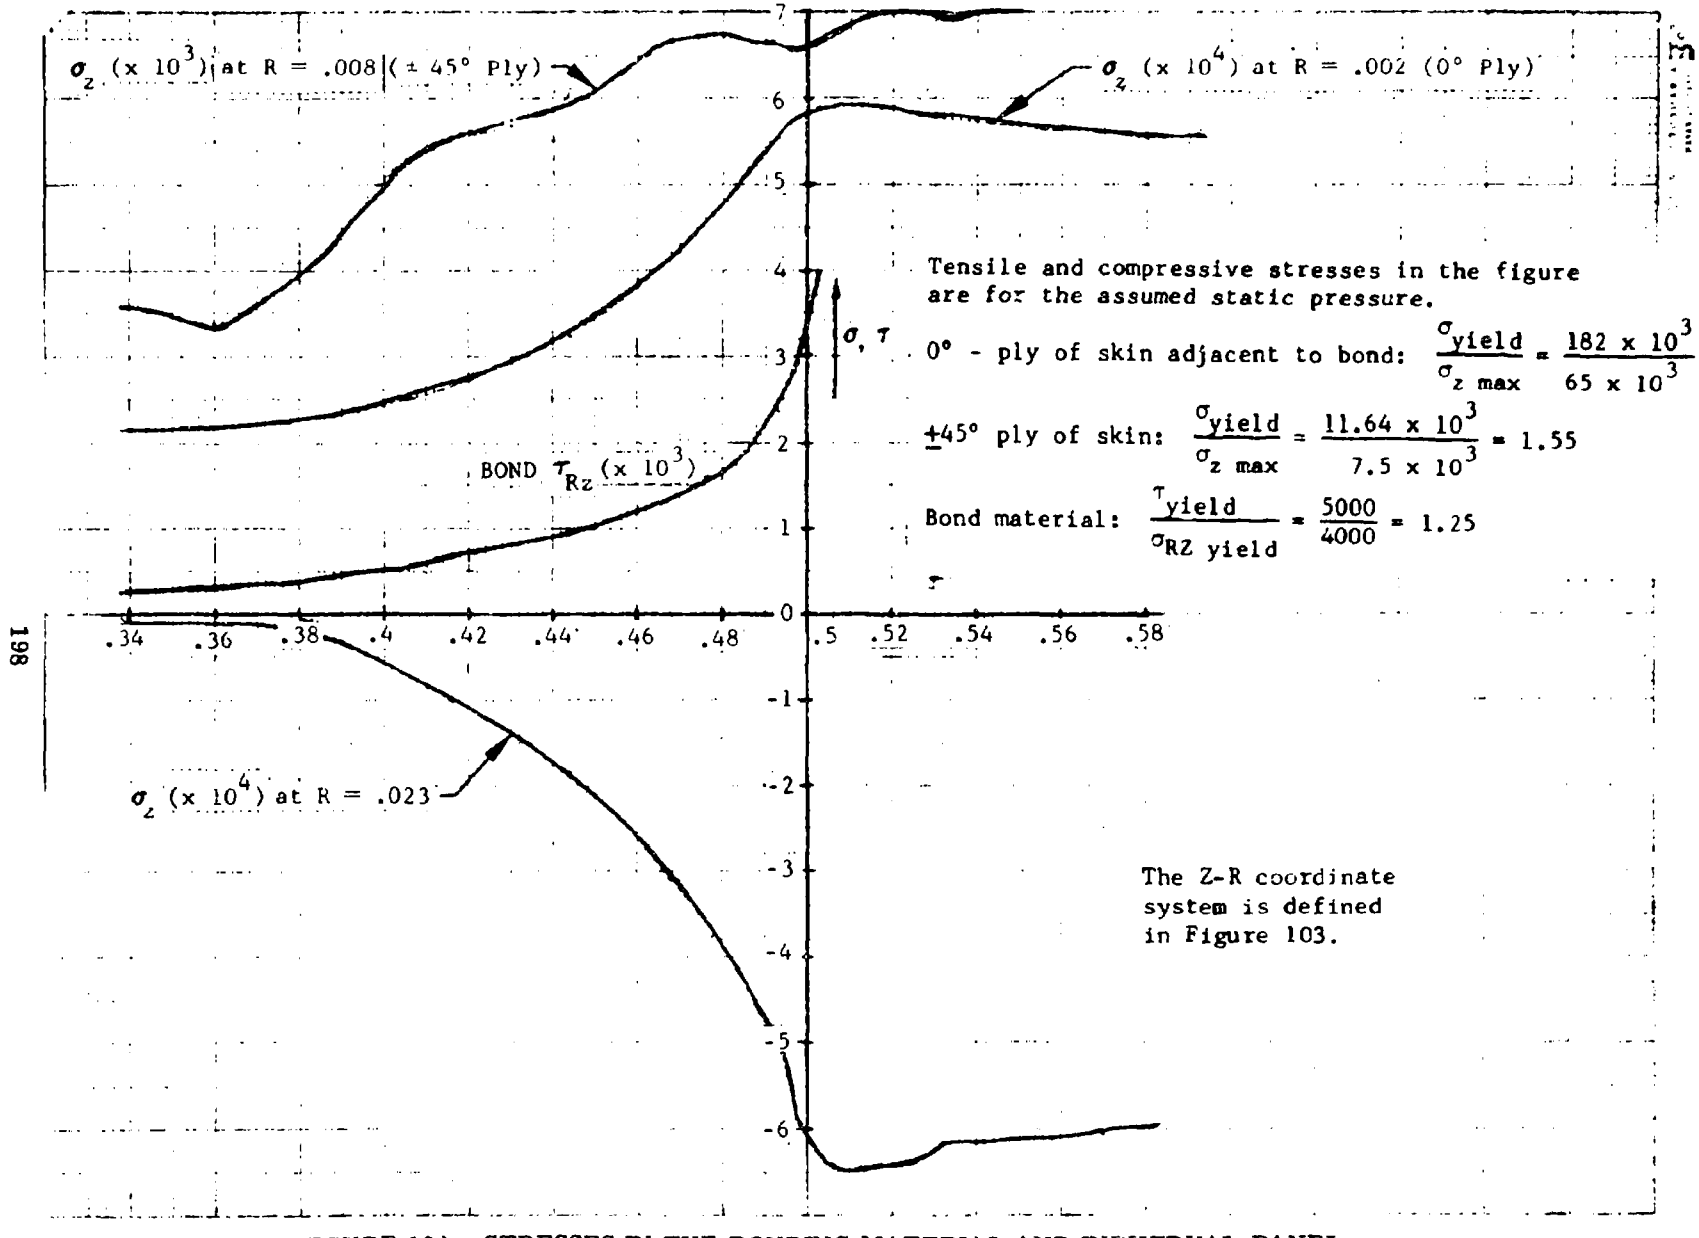
FIGURE 106. STRESSES IN THE BONDING MATERIAL AND INDIVIDUAL PANEL PLIES FOR CASE 2

Based on these results and the assumption that the material stress-strain curves were linear to the ultimate stress, it was concluded that for the acoustic test panels, the initial acoustic fatigue failure should be expected at or near the tee section stiffeners rather than at or near the I-beam stiffeners, since the most severely stressed (relative to yield stresses) finite element was in the 90 degree ply of the skin adjacent to the adhesive bond (see Figure 104 with the ratio $\frac{\sigma_{yield}}{\sigma_{z\ max}} = 0.49$ being the critical stress ratio). The results of this bonded joint analysis was a key factor in the selection of the Candidate A-2 type shaker specimen. Subsequently, in the fatigue tests of the shaker test specimens, the fatigue failures did occur in the skin of the 90 degree plies (Figure 87 and 88) as predicted by the analysis in this subsection.
